Degradation of the Aquatic Environment in Tujuh Muara Lake, Pamulang District, South Tangerang Affected by Urban Liquid Waste

Kevin Ewaldo ^{1*}, Evans Azka Fajrianshah ^{1,2}, and Supriatno ¹

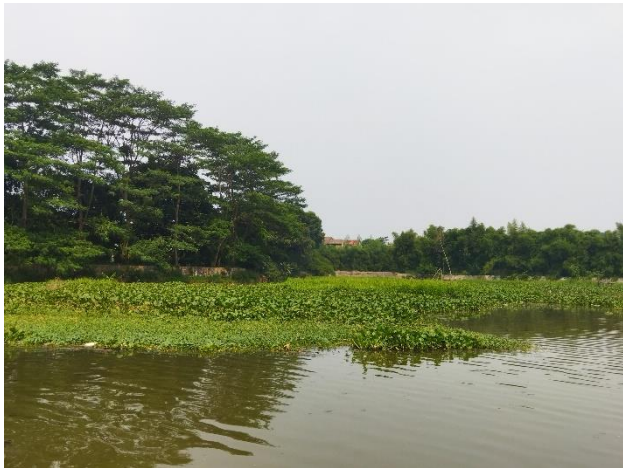
Figure 2. Condition of Water Hyacinth in the Inlet Area

The growth of the water hyacinth at the study site looks very high. At the inlet point (Figure 2), the high growth of water hyacinth causes siltation at the bottom of the lake. Silting that occurs can disrupt the sustainability of lake biota, reduce lake discharge, and in the long term can cause a reduction in the area and age of the lake.

1. Construction of the Constructed Wetland

Artificial wetlands or constructed wetlands can effectively and efficiently absorb excess nutrients from water bodies [30]. In addition, constructed wetlands have relatively low costs in construction, operation, and maintenance [31]. The treatment mechanism in constructed wetlands is to precipitate suspended particles; filtration processes and chemical precipitation occur through contact between the wastewater and the substrate (soil, sand, and gravel-supporting plants).

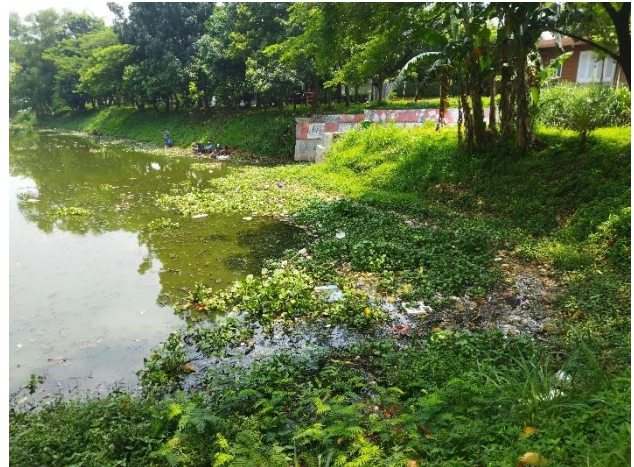
Figure 3. Condition of Water Hyacinth in the Outlet Area

The lush growth of water hyacinth does not only occur in the lake inlet area. In the lake outlet area, the growth of water hyacinth has a broader area. The growth of water hyacinth at this outlet location causes a blockage of the drains. In addition, in some parts of the outlet, the presence of water hyacinth causes garbage to become entangled and accumulate even more (Figure 3). The people who come to the location around the outlet ignore this condition and continue fishing activities without worrying about the dangers that can be caused. One member of the local NGO also mentioned that the degradation conditions that occurred had even led to a reduction in the area of the current TM lake. The activity of throwing garbage into the lake is still often carried out by the local community, thus worsening the condition and quality of the TM lake.

The high growth of water hyacinths on the surface of the water can reduce the penetration of sunlight into the water. This condition can cause reduced dissolved oxygen levels in water [28]. A decrease in the dissolved oxygen content in water will reduce the number of water producers in the food chain. In previous studies conducted in this
