# Experimental Study on the Failure Pattern of Cohesive Soil Under Finned Slabs Through Load Testing

Rapid infrastructure development requires reliable pavement systems, particularly on cohesive soils with low bearing capacity. This research investigates the addition of fins to pavement slabs as an innovative rigid pavement design. The study investigates how fins and their varying inclination angles ( $0^\circ$ ,  $30^\circ$ ,  $60^\circ$ ,  $90^\circ$ ) affect soil failure patterns, load bearing capacity, and deformation. Experimental tests were performed using a direct loading method with a jack on slab specimens placed in an acrylic box filled with cohesive soil. The results showed variations in soil failure patterns. The finless slab and  $90^\circ$  fin slab experienced shallow local shear failure, while the  $0^\circ$  fin slab exhibited punching shear failure due to stress concentration and vertical penetration. In contrast, the  $30^\circ$  and  $60^\circ$  finned slabs developed broader plastic zones resembling general shear failure, indicating improved stress distribution. Performance results showed the  $60^\circ$  finned slab achieved the highest ultimate load of 10.60

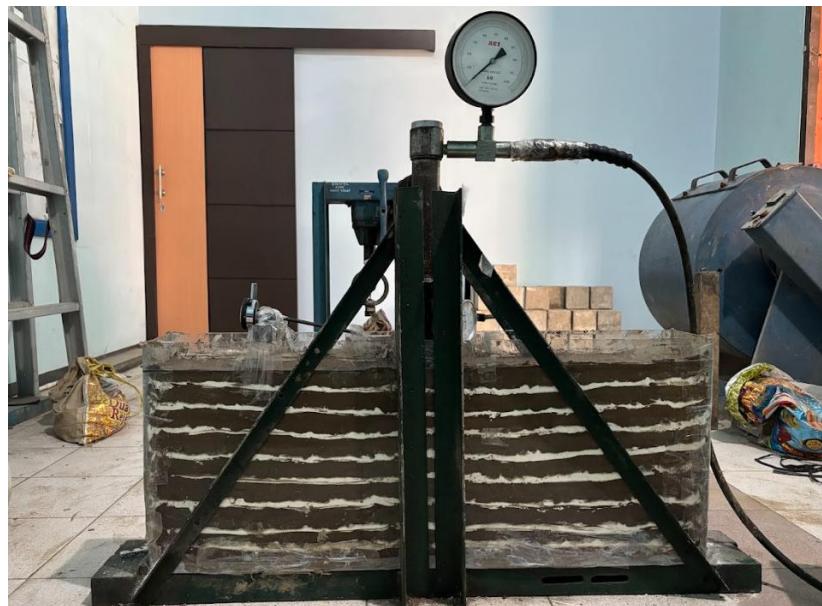
**Figure 6.** Front view of experimental tests of soil failure pattern

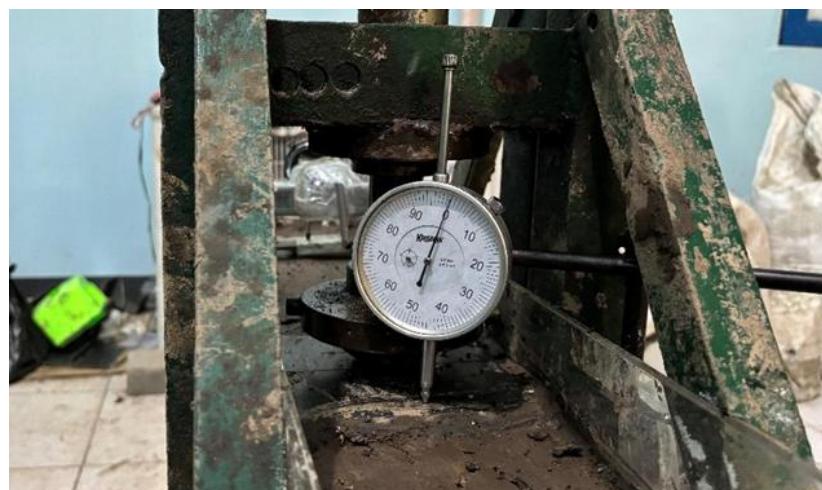
**Figure 7.** View of the slab under load

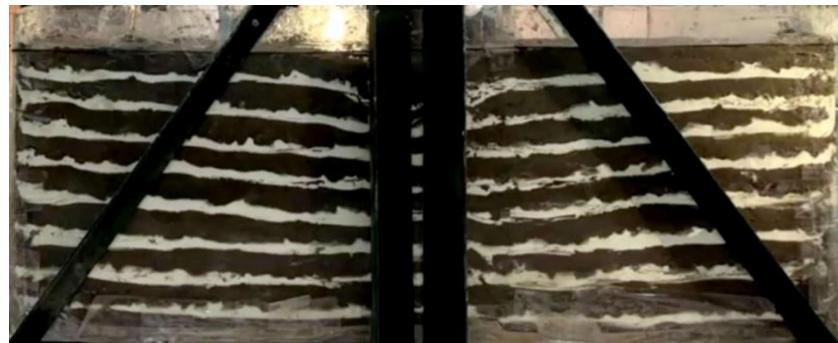
1. The test on the unfinned slab showed a local shear failure with partial soil displacement and no significant heaving. At a 9 kN load, the soil settled 50 mm. Stress was concentrated near the edges, with limited penetration and interaction. This resulted in low bearing capacity and rapid settlement, indicating the slab is unsuitable for soft cohesive soils without improvement.

Figure 8. Failure pattern of cohesive soil under the unfinned slab sample

Based on the analysis, the failure patterns and stress distribution varied with fin inclination. Slabs without fins and those with 90° fins showed local shear failure and shallow plastic zones. A 0° fin caused vertical stress concentration and punching shear, while 30° and 60° fins directed stress diagonally, enlarging the shear zone and improving load distribution.

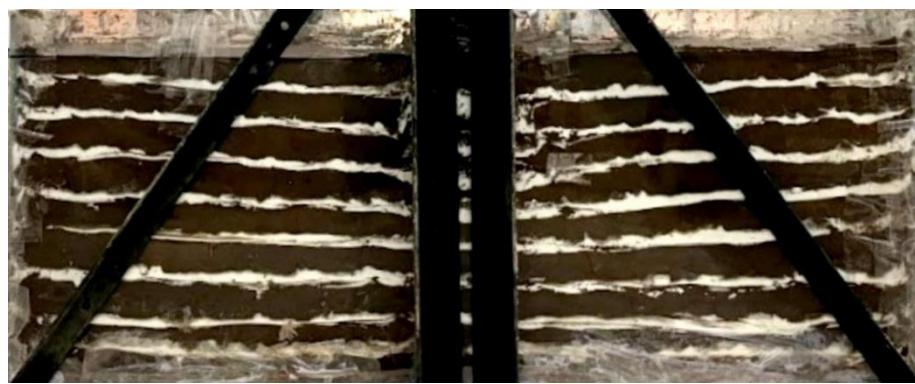
2. The finned slab with 0° inclination was tested, it also failed at 9 kN under similar settlement conditions. However, unlike the unfinned slab, the vertical fins acted as passive resistors to downward movement but did not effectively spread the load laterally. The soil exhibited a punching shear failure, marked by vertical penetration without significant lateral deformation or heaving. This suggests that at 0° inclination, the fins had minimal contribution in enhancing the soil's shear resistance or redistributing stress.

Figure 9. Failure pattern of cohesive soil under the finned slab sample with 0° inclination

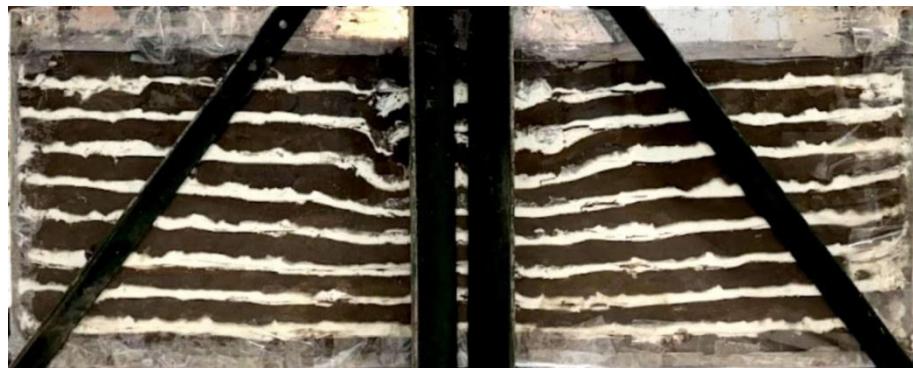
3. The finned slab with 30° inclination showed improved performance compared to the previous two. Failure occurred at a higher load of 15 kN, and local shear failure was observed. At 10 kN, slight ground heaving was detected, indicating that the inclined fins began to redirect part of the vertical load laterally into the soil. This redirection helped initiate a wider shear zone, although it was still not fully developed. The 30° fins increased interaction between the slab and the soil mass, showing better stress redistribution, although still not as optimal as steeper inclinations.

**Figure 10.** Failure pattern of cohesive soil under the finned slab sample with  $30^\circ$  inclination

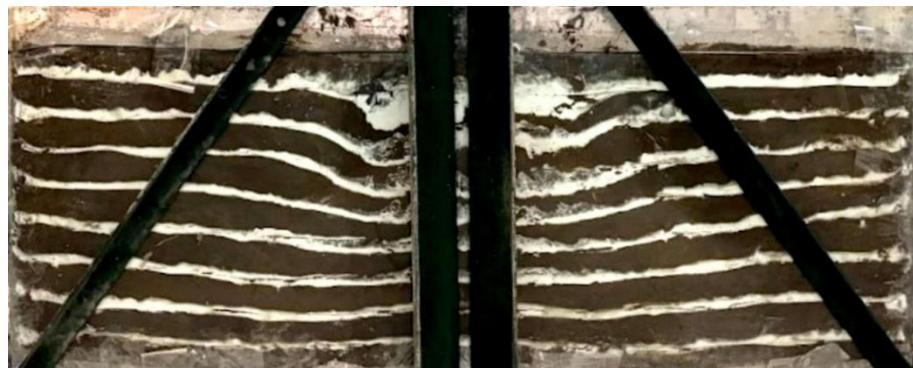
4. The finned slab with  $60^\circ$  inclination. This slab endured the highest load of 20 kN before failure, with local shear failure becoming visible after 8 kN. Ground heaving began at around 13 kN, suggesting a substantial lateral pressure buildup beneath the slab. The  $60^\circ$  fins effectively redirected vertical forces outward, resulting in a broader shear zone and improved stability. Although the failure was not yet general shear failure, the pattern indicated a transition toward it, reflecting enhanced stress dispersion and deeper load influence in the soil.

**Figure 11.** Failure pattern of cohesive soil under the finned slab sample with  $60^\circ$  inclination

In conclusion, the 60° finned slab provided the most favorable failure pattern, widest plastic zone, highest bearing capacity, and lowest settlement, as shown by its stable load-deformation curve. This study was limited to laboratory scale with a fixed fin geometry; thus, further research is needed before applying the findings to full-scale pavement.

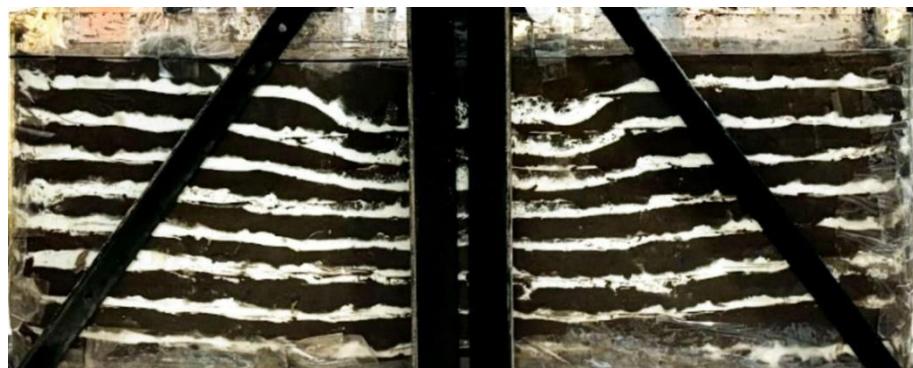
5. The finned slab with  $90^\circ$  inclination exhibited local shear failure at 12 kN. Ground heaving was observed early at around 5 kN, yet the failure pattern remained limited in scale. The vertical fins partially redirected stress laterally but restricted deeper soil engagement due to their upright geometry.

**Figure 12.** Failure pattern of cohesive soil under the finned slab sample with  $90^\circ$  inclination
