# The Impact of High-Temperature Exposure from Fire on Concrete Quality: A Review and Experimental Plan

This study was initiated following a fire incident at SD Negeri 022 Penajam, located on Jenderal Sudirman Street, Penajam Paser Utara Regency, East Kalimantan, Indonesia. The fire broke out on Wednesday, January 31, 2024, around 4:00 PM local time, destroying five rooms including three classrooms, the teachers' lounge, and the principal's office. The post-fire condition of the school is shown in Figure 1, where significant damage can be seen in the roof and wall elements, indicating the intense impact of the flames.

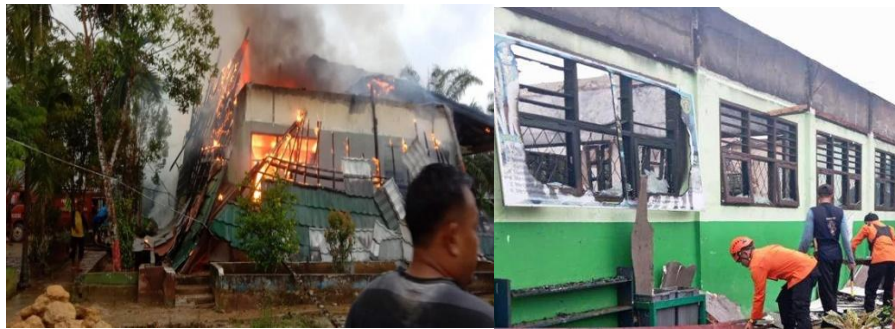
**Figure 1.** Post-fire condition of SDN 022 Penajam on January 31, 2024, showing partial destruction of the school building (photo: field documentation)

The case of the school fire in Penajam, which led to the demolition of the building, aligns well with the findings of this study. Concrete exposed to temperatures of up to 500°C had lost nearly half of its strength, and its microstructure had undergone irreversible degradation. Even if some elements appeared visually intact, they were structurally compromised. Hence, the decision to demolish the building was an appropriate and necessary step to ensure safety.

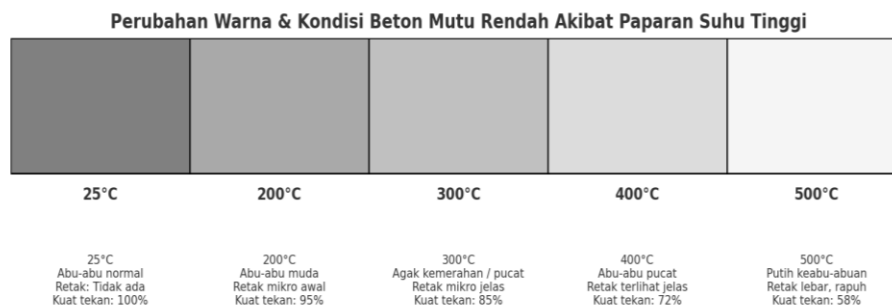
**Figure 3.** Illustration of color changes and surface condition of low-strength concrete after exposure to temperatures between 25°C and 500°C

The strength loss becomes more pronounced at around 28%. The damage is largely due to intensified decomposition of  $\text{Ca}(\text{OH})_2$ , which is commonly reported to accelerate beyond  $\sim 400^{\circ}\text{C}$  in normal concrete [2], [3]. In field observations, concrete subjected to this level of heat showed more visible cracking and discoloration, ranging from grayish tones to reddish hues depending on the type of aggregate used.

Visually and mechanically, fire-exposed specimens ( $\geq 400^\circ\text{C}$ ) displayed a different failure pattern compared to unexposed concrete. Numerous surface microcracks formed, and failure became more brittle specimens tended to break in a “soft,” crumbling manner with cracks propagating widely indicating a weakened microstructure caused by heat exposure [2].
